FIG Services LLC d/b/a FOX INSPECTION GROUP  
Property Inspection Report #140923srgm-1614 Wakefield  
11227 Endicott Lane Houston, TX 77035

## PROPERTY INSPECTION REPORT

Concerning: 1614 Wakefield, Houston, TX 77018

By: Steven Reid, TREC# 7248, Grant Miller, AI# 20975 09/23/2014

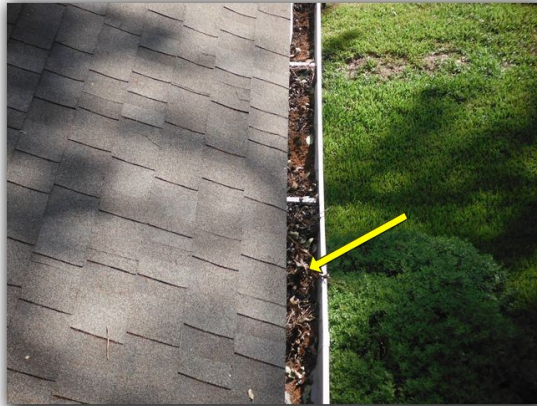
Full of debris and/or holds standing water.

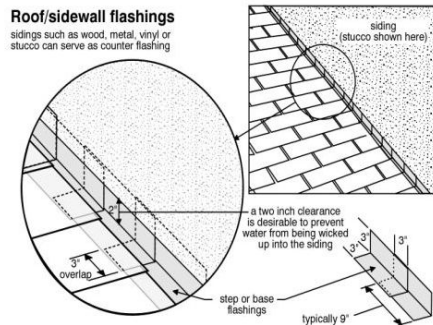
Exterior cement board siding installation does not comply with manufacturer's (James Hardie ) installation requirements which may/can/will void warranty. Installation requirements specifically state " Leave 2" clearance between roofing and bottom edge of siding.

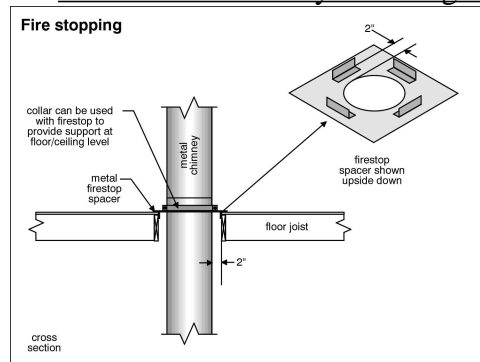
Chimney is not properly fire stopped in attic ; Does not comply with the 1992 CABO One and Two Family Dwelling Code section R-402.7 IRC R1001.16.
